***Top Workmanship Quality Issues:***

**Timeframe:** [April 2006](#)

# Americas Top 5 Defects MTD

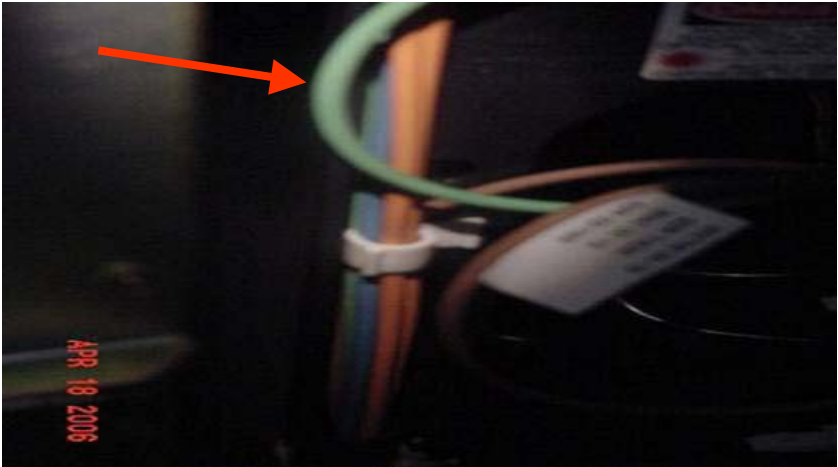
**Routing Cables:** Fiber cable not secured within the routing clips

Loose or unsecured fiber patch cords may accidentally be tug or pull by an individual passing or working around the bay.

(Procedural Non-Adherence) - The Installation team was not aware or did not understand that IM requirements.

**Correct Method :** Fiber patch cords need to be secured with routing clips of the UFXPM Bracket IM 03-9059 Fig 409.

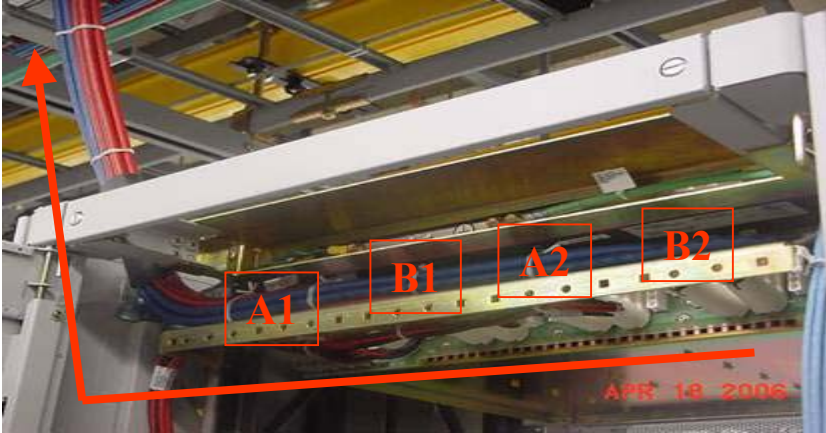
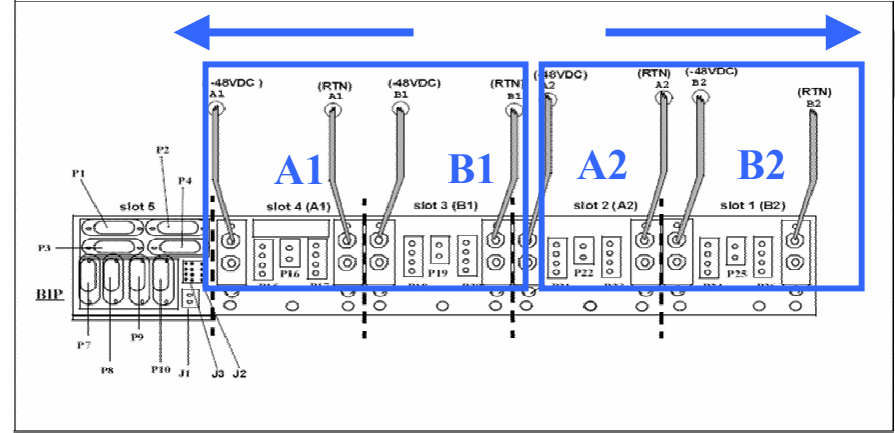
**Securing Cables:** A2 & B2 power cables have been incorrectly routed to the left rear of the BIP.

This will lead to inconsistency and cable congestions at the top of the frame.

(Training) – The technician was not aware that this was an IM requirement; however, proceed to install the power cables as per the previous footprint of the office.

**Correct Method :** As per the IM08-1543 section 4.8. A1 & B1 power cables are to be into the top of the frame on the left rear. A2 & B2 power cables are to be into the top of the frame on the right rear

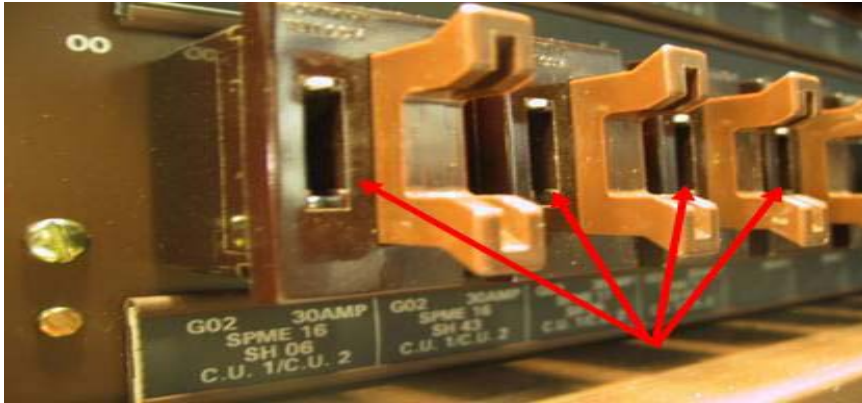
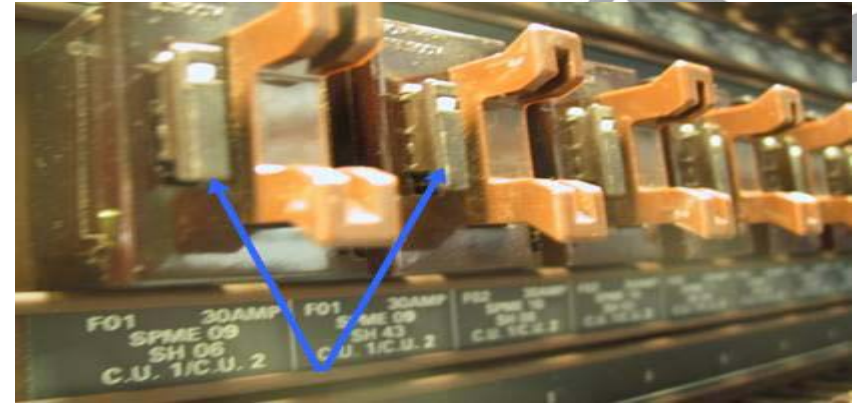
**Fusing :** Guard fuses not installed within the fuse holder.

- This can result in not being able to determine which fuse cartridge may have been fused without the indication to the guard fuse indicator.

Installation team did not adequately communicate or log outstanding work for the next shift team to complete the job.

**Correct Method:** Guard fuses are installed as per IM 22-0162, section 3.1 fig 2
