***Top Workmanship Quality Issues:***

**Timeframe:** August 2006

# Americas Top 5 Defects MTD

# Americas Final Audits

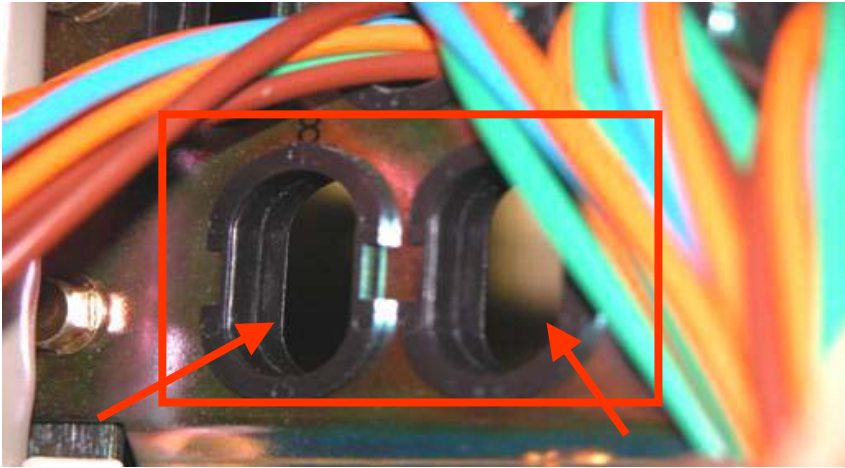
**Routing Cable :** Incorrect fiber port used on the ENC 00 right bulkhead:  
 C/P 14R -. Prt hole No.11 used. Must use port hole 8  
 C/P 15R -. Prt hole No. 6 used. Must use port hole 9  
 Both portholes 8 & 9 are empty

Improper routing of fiber cable thru the bulkhead will cause congestion pile-up and confusion for future expansions.

The job was incorrectly captured as closed from the contracting company and a final/checklist was not completed. Also, the technician was new and was not aware of the standards requirements.

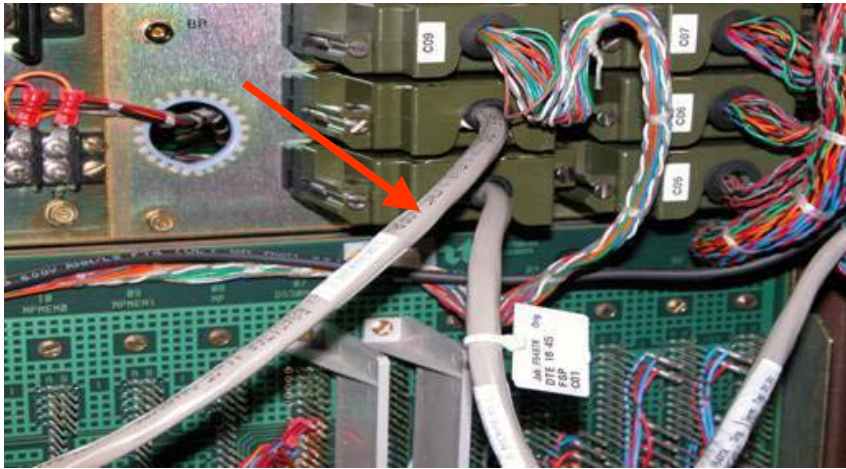
**Cabling (Non-Fiber) designations:** Missing Aisle Alarm cable designation label at C02 connection

Incorrect cable designation may lead to service interruption if incorrect leads are removed or may cause confusion and time loss in trying to troubleshoot or identify the cable in the future.

Technician had forgotten to apply the flag ty-rap designation to the Aisle Alarm cable.

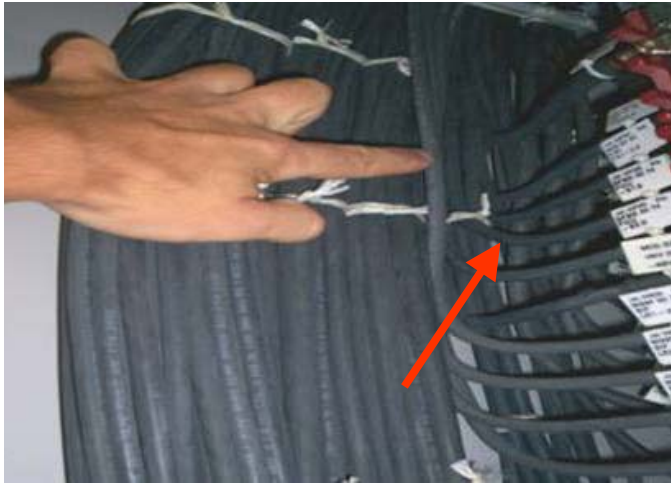
**Routing Cable :** Power cables are not secured within the frame or within the previous cable forms.

Not securing cables may create a risk of damaging the cables or exerting stress on the connection which can lead to a service interruption.

A different crew had completed the job assuming that all prior work was done as per standard. A complete check was not done after completion of the job.
