***Top Workmanship Quality Issues:***

**Timeframe:** [May 2006](#)

**Snap Shots of the Month**

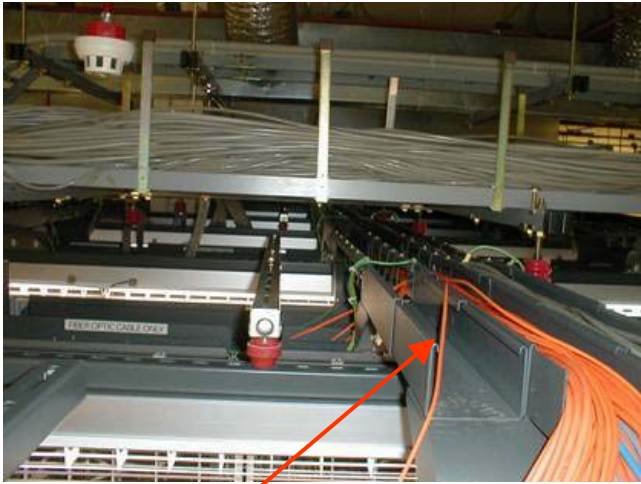
**Routing Cables:** Fiber Management issue Fiber Cable is not to run outside of its dedicated management system.

Incorrect cable routing places risk of damaging the cables which would lead to a service interruption.

Failure to follow proper procedure. During the fiber routing process technician did not notice the fiber was out side of the fiber duct. Over look during final site inspection.

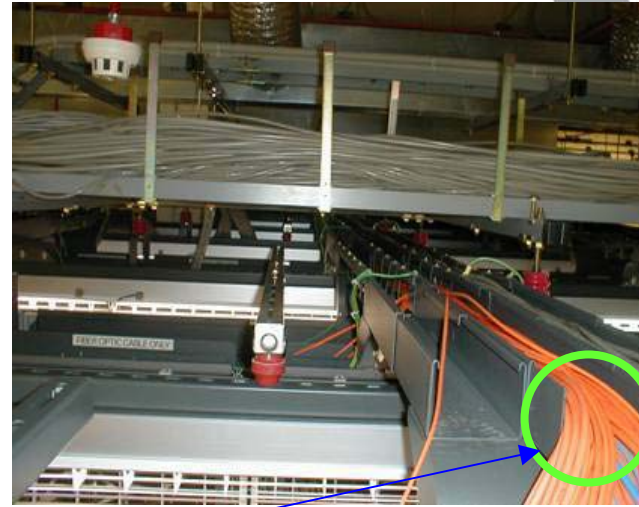
**Correct Method :** Fibers cables to the right are correctly routed.

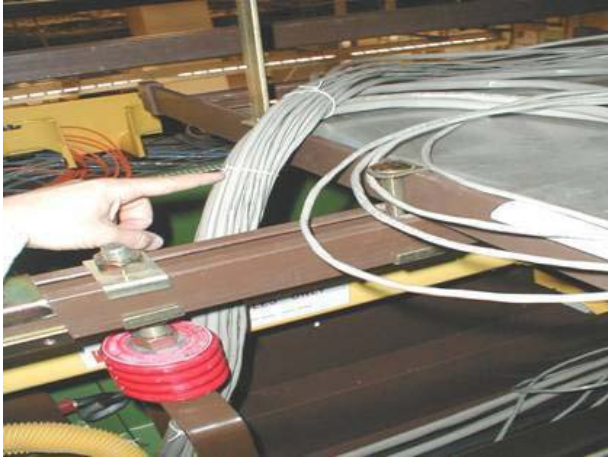
**Securing Cables:** Cables are not secured and no cable protection added.

Improper, not securing cables and not cable protection can create a risk of damaging the cables. Which can lead to a service interruption.

Technician followed existing pattern, existing cables were not secured to the rack at break, our cables added to the bundle.

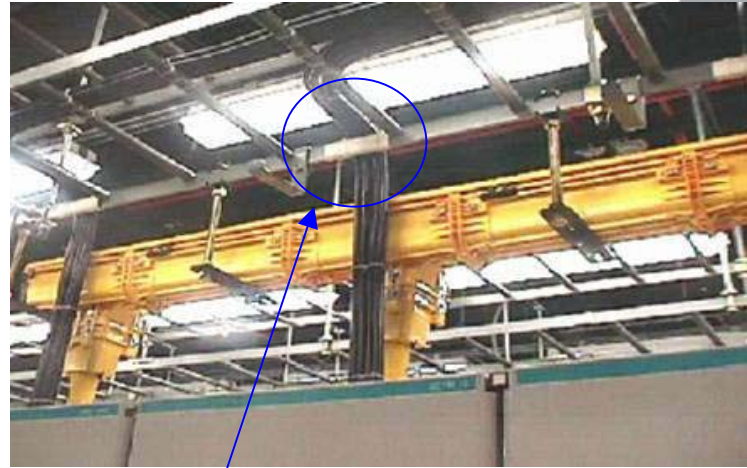
**Correct Method :** Cables are properly secured to the cable rack.

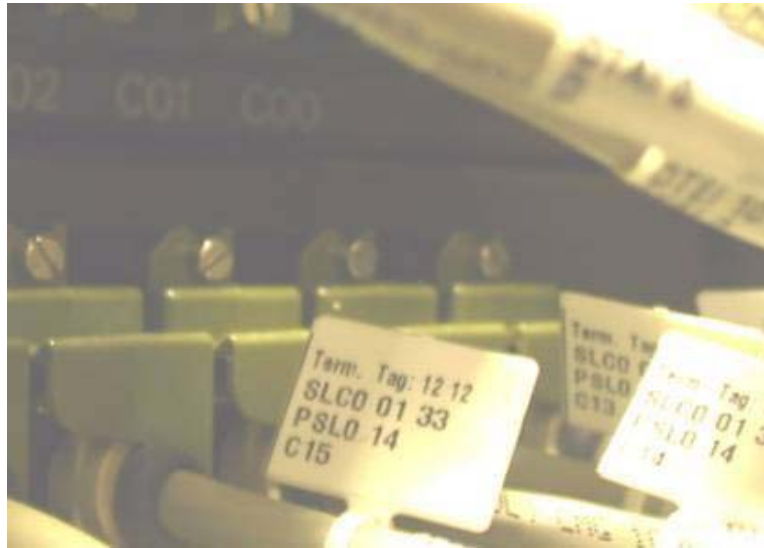
**Cabling (Non-Fiber) designations :** Incorrect cable designations for the terminating end on the on the SLC Bays. It should be terminating to PNL 36 instead of PNL 33 and connection points at C12-C14 instead of C00-C03.
