***Top Workmanship Quality Issues:***

**Timeframe:** [April 2006](#)

# Americas Top 5 Defects MTD

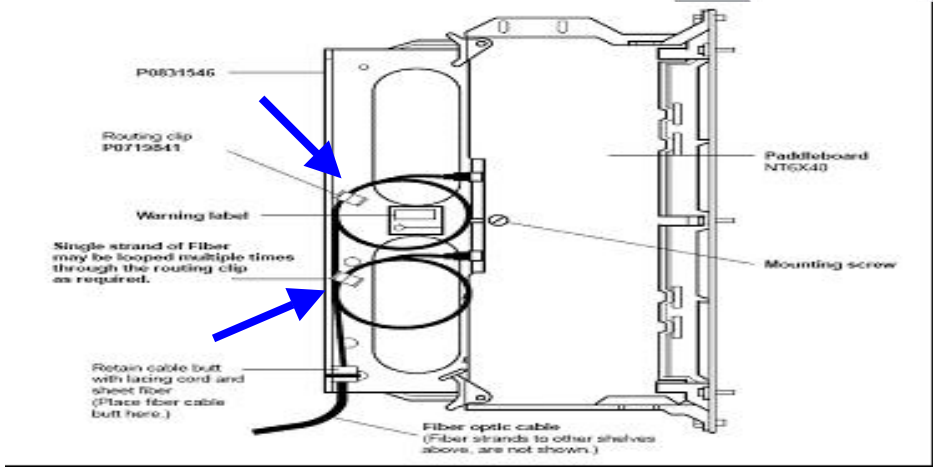
**Routing Cables:** Fiber cable not secured within the routing clips

Loose or unsecured fiber patch cords may accidentally be tug or pull by an individual passing or working around the bay.

(Procedural Non-Adherence) - The Installation team was not aware or did not understand that IM requirements.

**Correct Method :** Fiber patch cords need to be secured with routing clips of the UFXPM Bracket IM 03-9059 Fig 409.

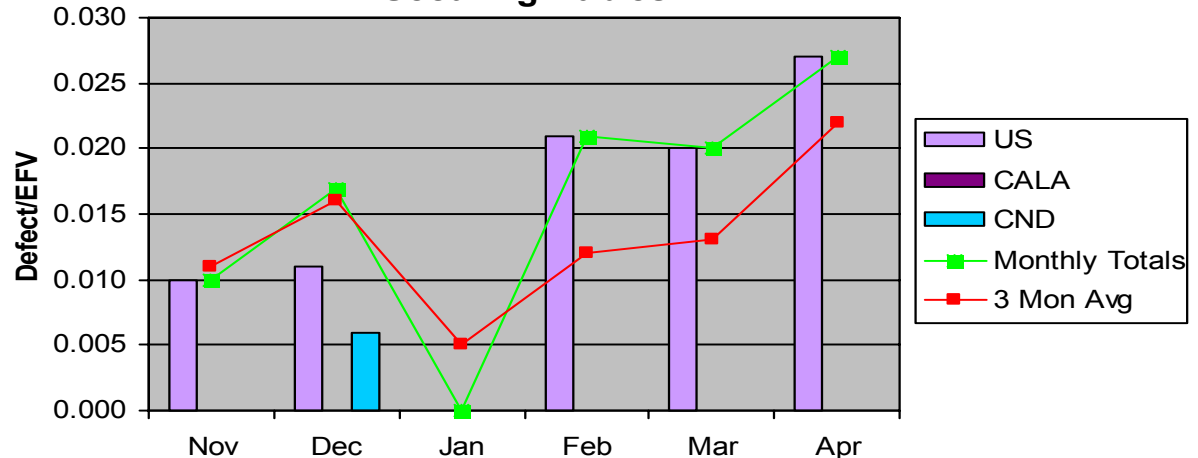
**Securing Cables**

**Securing Cables:** A2 & B2 power cables have been incorrectly routed to the left rear of the BIP.

This will lead to inconsistency and cable congestions at the top of the frame.

(Training) – The technician was not aware that this was an IM requirement; however, proceed to install the power cables as per the previous footprint of the office.

**Correct Method :** As per the IM08-1543 section 4.8. A1 & B1 power cables are to be into the top of the frame on the left rear. A2 & B2 power cables are to be into the top of the frame on the right rear

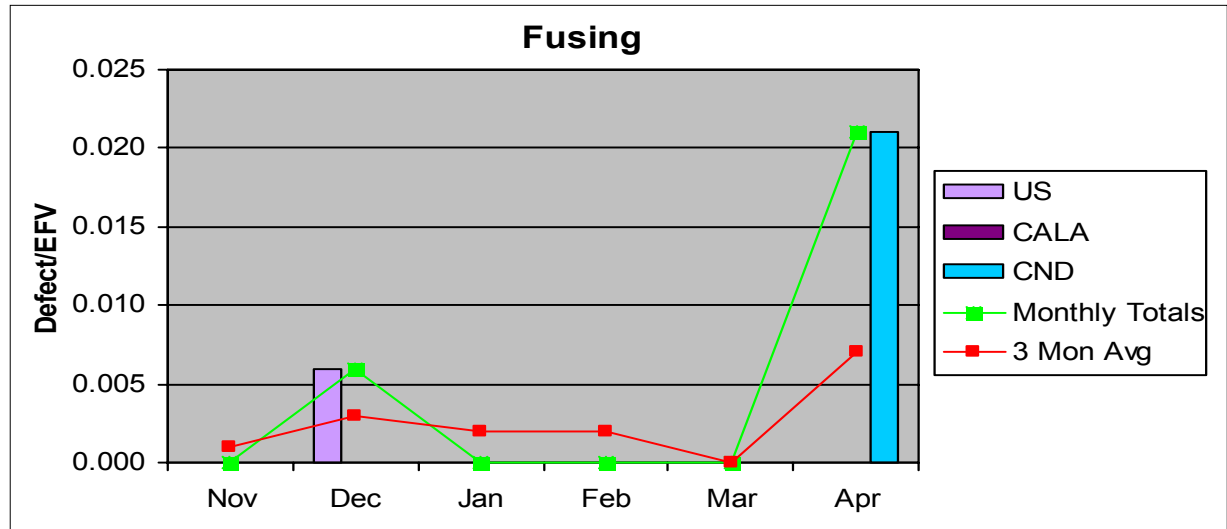
**Fusing :** Guard fuses not installed within the fuse holder.

- This can result in not being able to determine which fuse cartridge may have been fused without the indication to the guard fuse indicator.

Installation team did not adequately communicate or log outstanding work for the next shift team to complete the job.

**Correct Method:** Guard fuses are installed as per IM 22-0162, section 3.1 fig 2
