***Top Workmanship Quality Issues:***

**Timeframe:** August 2006

# Americas Top 5 Defects MTD

# Americas Final Audits

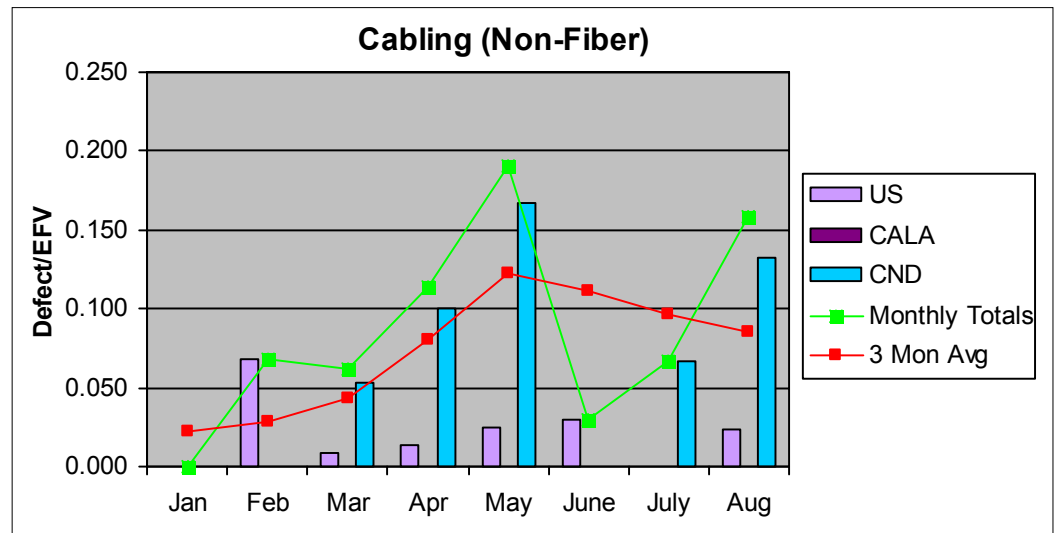
**Cabling (Non-Fiber) designations:** Missing Aisle Alarm cable designation label at C02 connection

Incorrect cable designation may lead to service interruption if incorrect leads are removed or may cause confusion and time loss in trying to troubleshoot or identify the cable in the future.

Technician had forgotten to apply the flag ty-rap designation to the Aisle Alarm cable.

**Cabling (Non-Fiber) designations :** Proper way to label the Aisle Alarm Cables

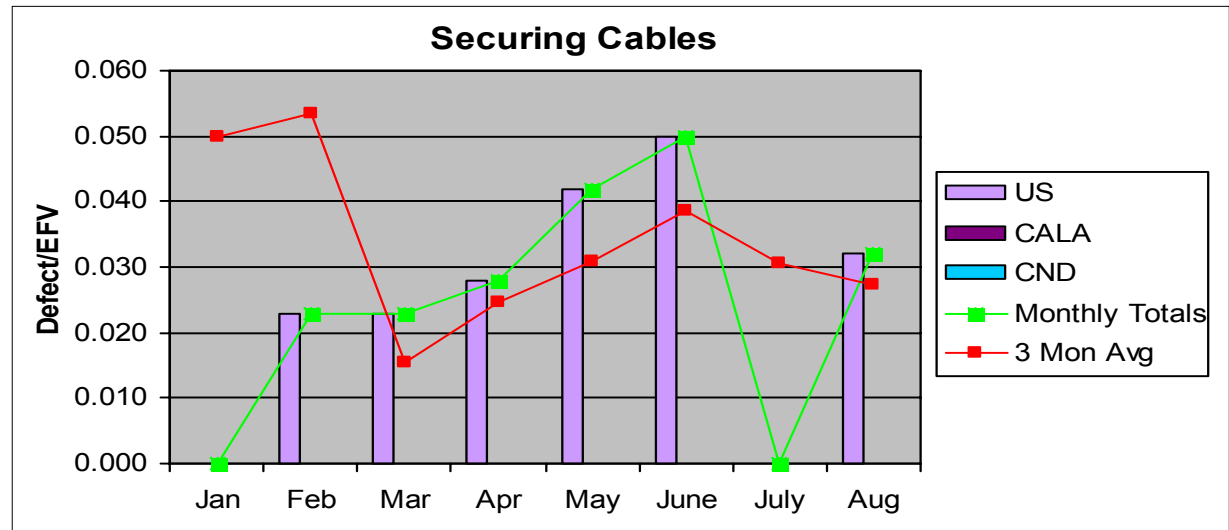
**Routing Cable :** Power cables are not secured within the frame or within the previous cable forms.

Not securing cables may create a risk of damaging the cables or exerting stress on the connection which can lead to a service interruption.

A different crew had completed the job assuming that all prior work was done as per standard. A complete check was not done after completion of the job.

**Routing Cable :** Proper way is to add the additional cables within the previous cable form.
