***Top Workmanship Quality Issues:***

**Timeframe:** [May 2006](#)

**Snap Shots of the Month**

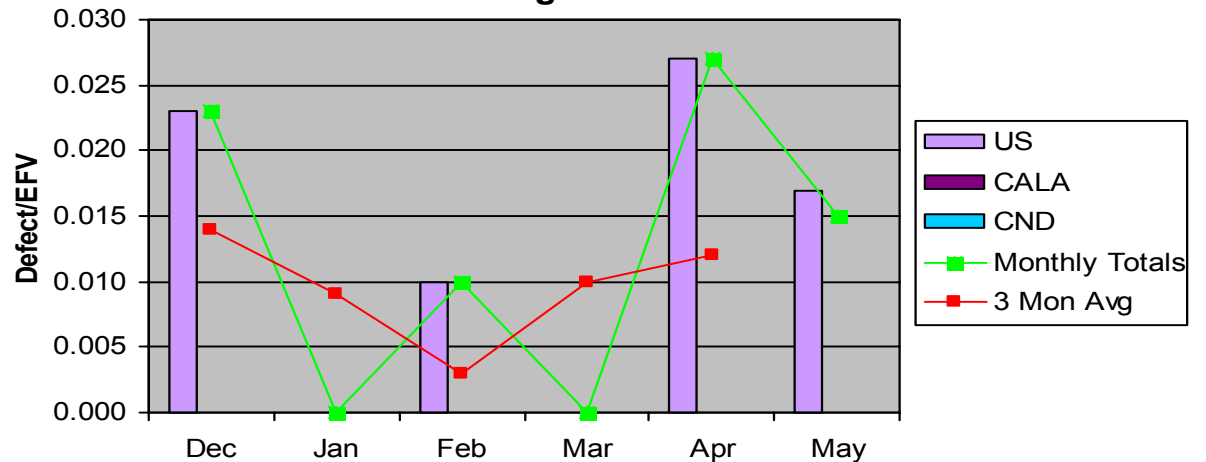
**Routing Cables**

**Routing Cables:** Fiber Management issue Fiber Cable is not to run outside of its dedicated management system.

Incorrect cable routing places risk of damaging the cables which would lead to a service interruption.

Failure to follow proper procedure. During the fiber routing process technician did not notice the fiber was out side of the fiber duct. Over look during final site inspection.

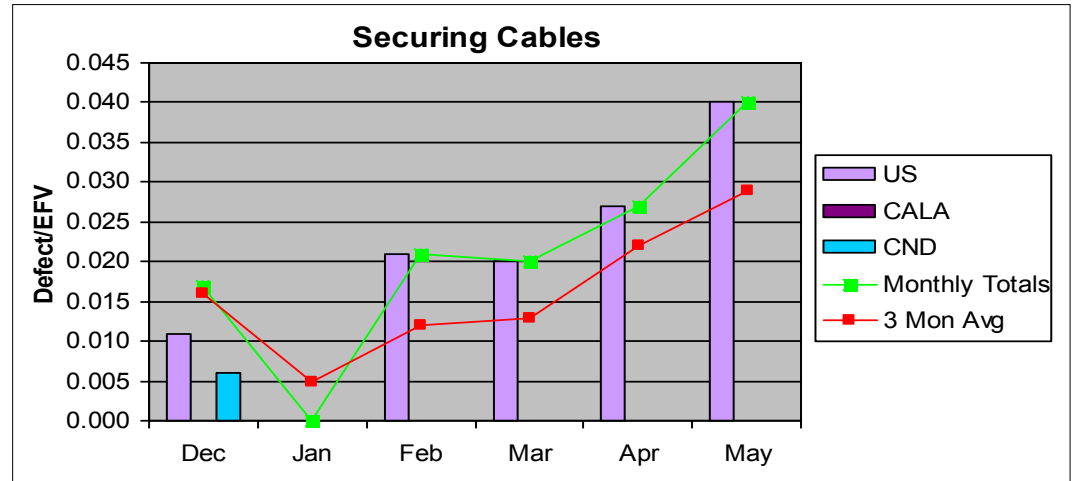
**Securing Cables:** Cables are not secured and no cable protection added.

Improper, not securing cables and not cable protection can create a risk of damaging the cables. Which can lead to a service interruption.

Technician followed existing pattern, existing cables were not secured to the rack at break, our cables added to the bundle.

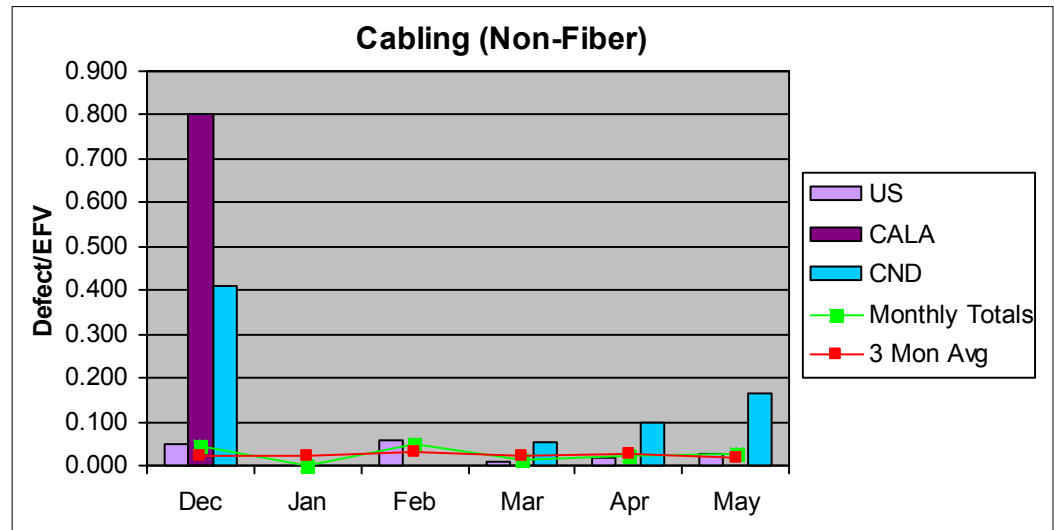
**Cabling (Non-Fiber) designations :** Incorrect cable designations for the terminating end on the on the SLC Bays. It should be terminating to PNL 36 instead of PNL 33 and connection points at C12-C14 instead of C00-C03.
